MARYLAND HISTORICAL TRUST NR-ELIGIBILITY REVIEW FORM

Property Name: Edmonson Avenue Bridge (BC2202)	Inventory Number: B-4548						
Address: Gywnns Falls	City: Baltimore	Zip Code: 21223					
County: Baltimore City USGS Topographic Map: Baltimore West, MD							
Owner: Baltimore City							
Tax Parcel Number: N/A Tax Map Number:	N/A Tax Account ID Number: N/A						
Project: Proposed Phase 2 Gywnns Falls Pathwa	y Agency: Maryland State H	lighway Administration					
Site visit by MHT Staff: X no yes	Name:	Date:					
Eligibility recommended	Eligibility not recommende	d_X_					
Criteria:ABCD	Considerations:ABC	DEFG <u>X</u> None					
Is the property located within a historic district?	X noyes Name of district:						
Is district listed?noyes Determined	eligible?noyes District l	Inventory Number:					
Documentation on the property/district is presented	d in: P.A.C. Spero & Company and Louis Historic Highway Bridges in Maryla						
	Report. Maryland State Highway A Department of Transportation, Balti	dministration, Maryland State

MARYLAND INVENTORY OF HISTORIC BRIDGES HISTORIC BRIDGE INVENTORY MARYLAND STATE HIGHWAY ADMINISTRATION/MARYLAND HISTORICAL TRUST

SHA Bridge No. BC 2202 Bridge n

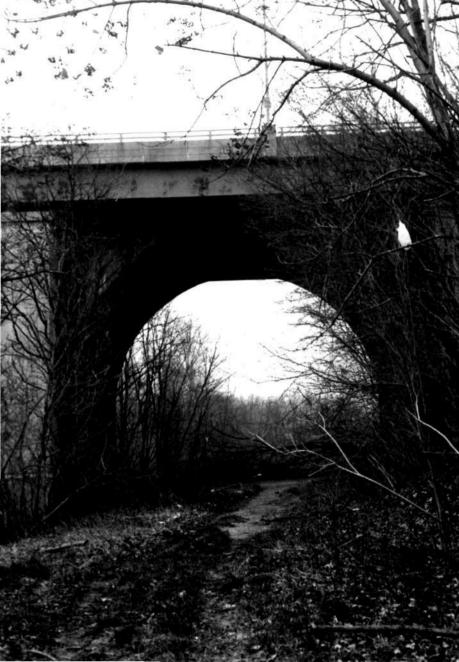
MIHP#: B-4548 EDMONSON AVENUE BRIDGE BATIMORE CITY, MD WARD BUGHER MARCH 2000 VIEW TAKEN LOOKING NORTH AT EDMINSON HENVE BELDGE #1 OF 1

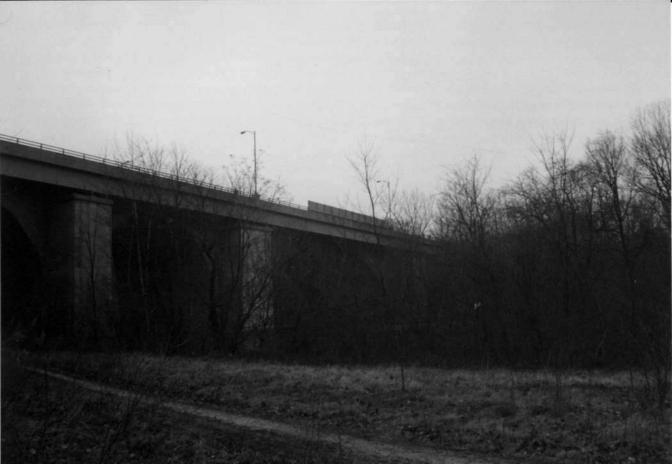
Inventory # <u>8-4548</u>
2202-US 40 EDMONDSON AVE OVER
Name GWYNNS FALLS AND CSX RR
County/State BALTIMOME CITY/MD
Name of Photographer Tim SCHOEN
Date 1/95
Location of Negative SHA
Description NORTH ELEVATION
Number 27 of 36 1 1 5

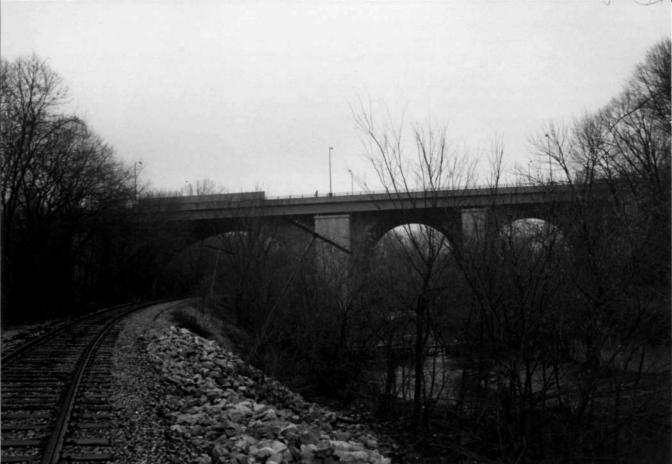
Inventory # <u>B-4548</u>	V90000
2202-US 40 EDMONOSON AVE	DVER
Name GWYNNS FALLS AND CSX R	R
County/State BALTIMORE CITY MD	
Name of Photographer TIM SCHOEN	
Date 1/95	
•	
Location of Negative SHA	
Description South ELEVATION	
Number 2 06 5	
•

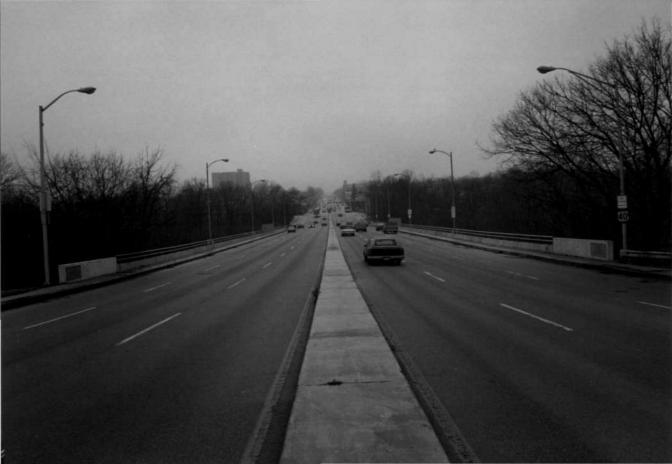
2202-US 40 EDMOND SON AVE WER
2702-US 40 EISMOID
Name GWYNNS FALLS AND ESX RR
County/State BALTIMORE CITY/MD
Name of Photographer IM SCHOEN
Date 1/95
Location of Negative SNA
Description EAST APPROACH
Number 30 of 36 4 8 5

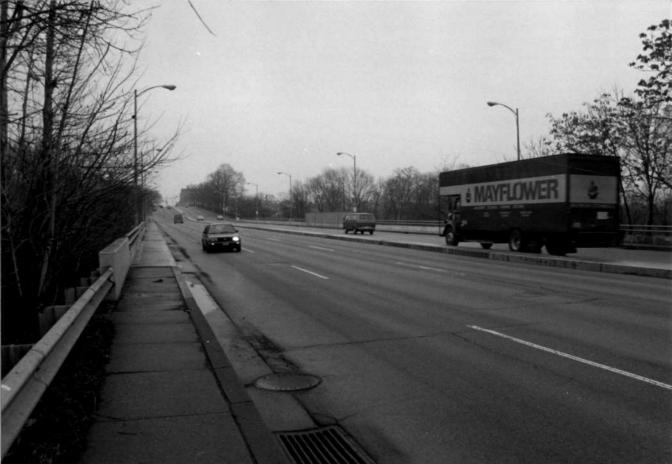
Inventory # <u>8-4548</u>
2202 - US 40 EDMUNDSON AVE OVER
Name GWYNNS FALLS AND CSX RR
County/State BALTIMORE CITY /MD
Name of Photographer TIM SCHOEN
Date 195
Location of Negative SNR
Description WEST APPROACH
21-24 - 01
Number 31 of 36 5 8 5
